Thermal characterization of an interior space of colonial architecture in Arequipa, comparative analysis of thermal transmittance of ignimbrite (sillar) envelope and contemporary material (drywall)

Fernando Cuzziramos-Gutiérrez¹
Daniela Paredes-Malma²
Sergio Coll-Pla^{3,b}

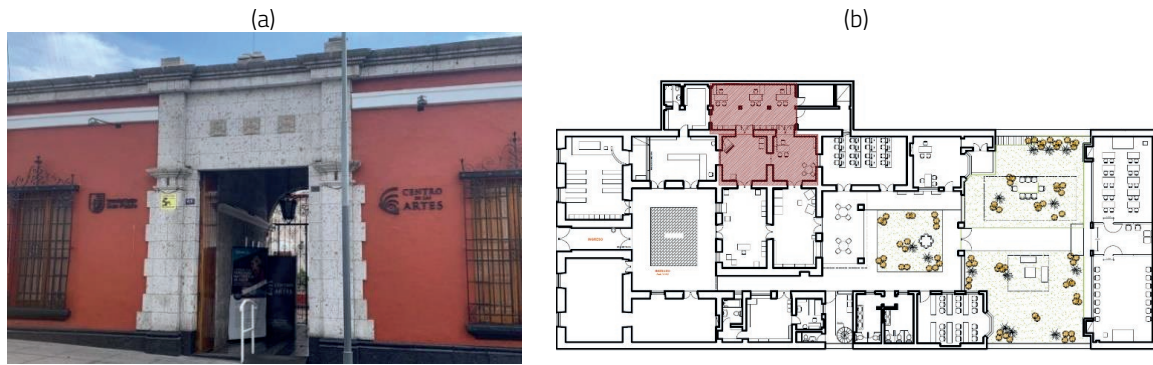
Figure 1. UCSP Center for the Arts, (a) Plan of the building with the office spaces without ventilation or natural lighting marked. (b) photo of the facade of the building. Own elaboration.

The first case study corresponding to the The Center for the Arts of the UCSP, the building is located in the historic center of the city of Arequipa, on Palacio Viejo street. the building that corresponds to the typology of the colonial courtyard house of Arequipa, the structure of the building is composed of ignimbrite (sillar) with walls with a system called "muro de cajón" characteristic of the colonial houses of Arequipa and flat roofs made up of rails, the interior spaces are distributed around two main yards, the entrance has with a "zaguán", a traditional space within the structure of Arequipa's colonial housing that connects the interior of the house with the exterior of the city.

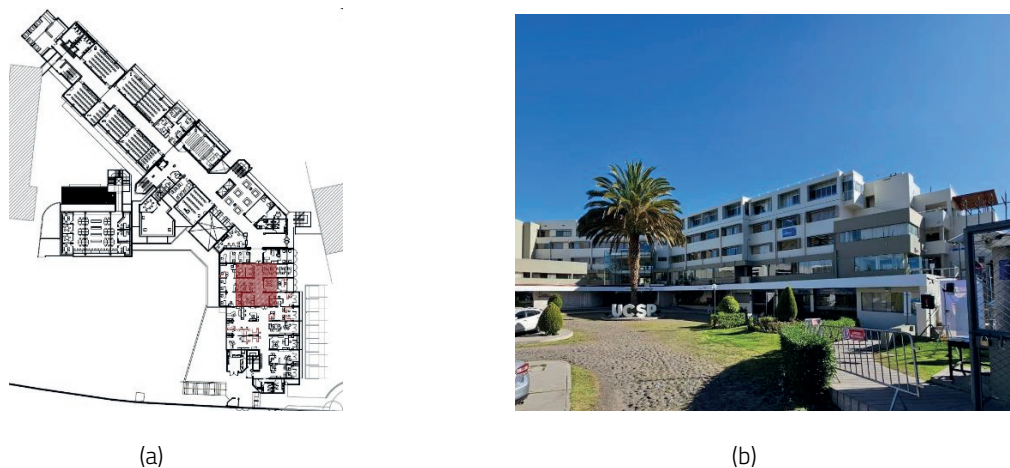
Figure 2. UCSP St. John H. Newman Building, (a) Plan of the building with the office spaces without ventilation or natural lighting marked. (b) photo of the facade of the building. Own elaboration.

Among the main uses of the Newman building are: classrooms, dining rooms, laboratories, office spaces and services. The construction system of the building corresponds to the reinforced concrete frame, and uses the drywall to organize and divide the various environments. Because the uses of the building are adapted, there are environments such as offices that are left without lighting or natural ventilation. These spaces do not use artificial air conditioning instruments such as air conditioning or heaters.

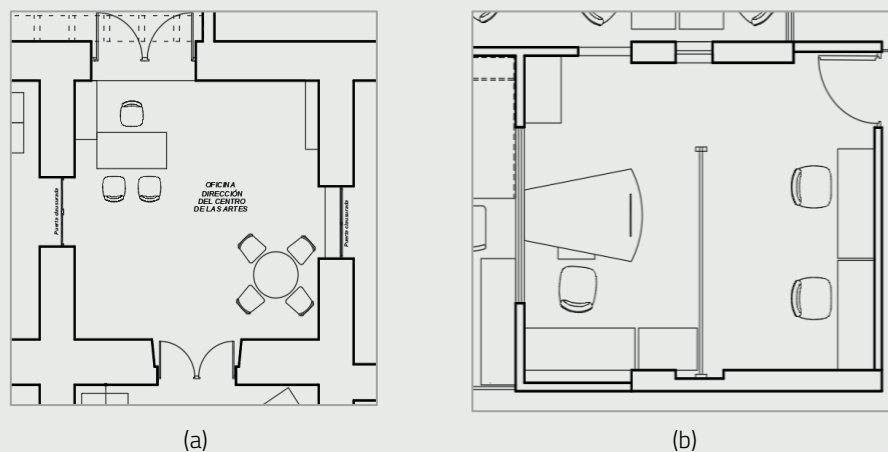
Figure 3. Floor plans of the measured office environments, (a) UCSP Arts Center Office and (b) UCSP St. John H. Newman Building Office. Own elaboration.

The selected environments were surveyed in situ where the architectural qualities of the ignimbrite (sillar) and drywall envelopes are evident, as shown in Figure 3.

The ignimbrite office corresponds to the UCSP Center for the Arts and has walls with an average thickness of 0.65 m. The drywall office corresponds to the UCSP San John H. Newman building and has walls with an average thickness of 0.15 m.

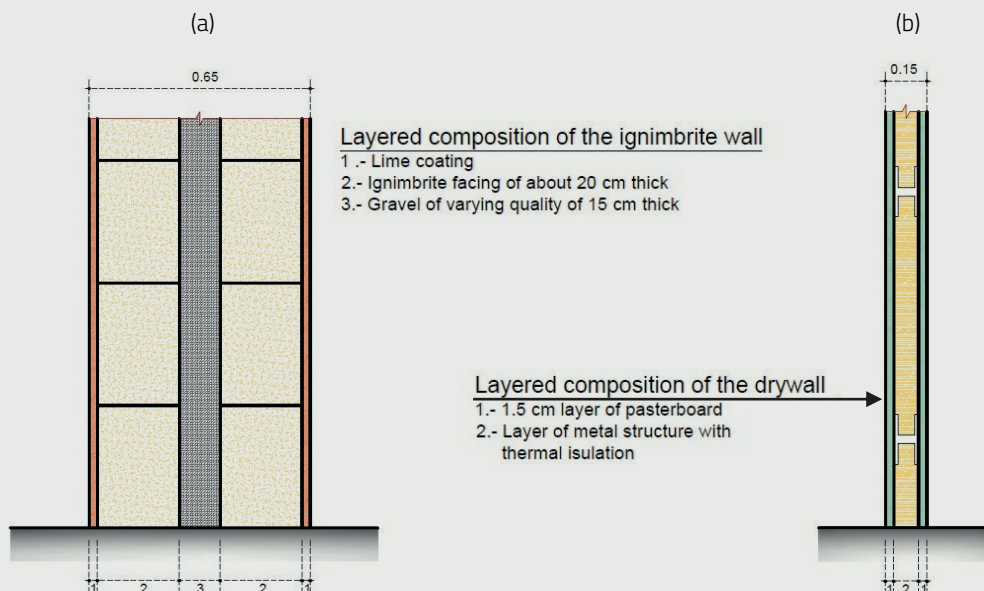
Figure 4. Modeling of the thermal envelope of: (a) Ignimbrite walls with a “Muro de cajón” construction system in offices of the UCSP Center for the Arts (b) Drywall walls in offices of the St. John H. Newman Building Office. Own elaboration.

The modeling of the thermal envelope of the selected offices consists of the identification of the layers that make up the enclosing walls that will later be measured to identify their thermal transmittance, as shown in Figure 4.

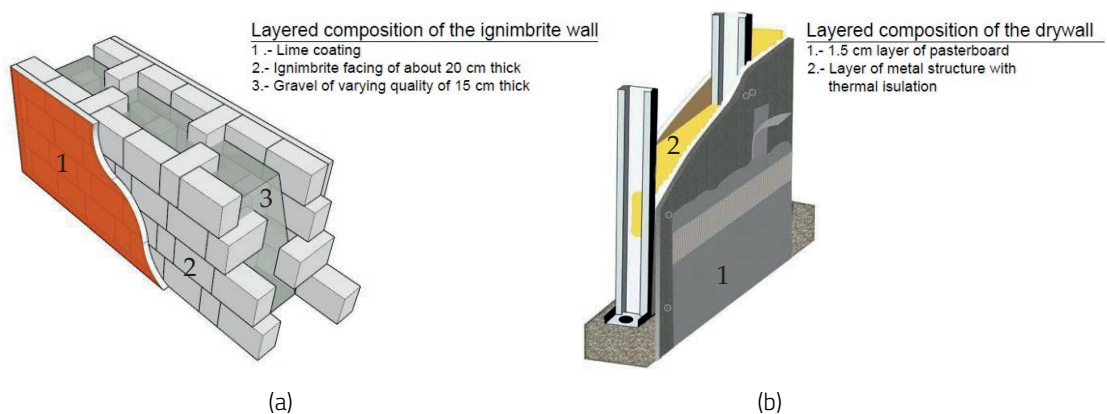
Figure 2. (a) Isometry of ignimbrite wall (b) Isometry of drywall wall. Own elaboration.

The ignimbrite wall is characterized by having five layers intertwined between them, the first is a lime coating that in many cases has been removed from both the exterior and the interior, the second layer is of ignimbrite facing of about 20 cm thick, the central layer is of gravel of varying quality of 15 cm thick to finish with a layer of ashlar facing of 20 cm thick and lime coating.

The drywall wall is composed of three layers starting with a 1.5 cm layer of plasterboard, a central layer of metal structure with thermal insulation and a layer of plasterboard. Basically, the insulation is centered on the thickness of a material. The material components can be seen in Figure 2.

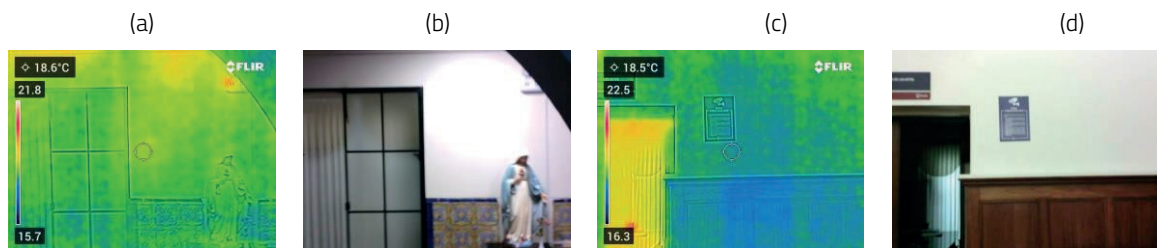
Figure 3. (a) (b) Thermographic photograph 1 of the exterior of the ashlar office;
(c) (d) Thermographic photograph 2 of the exterior of the ashlar office;
(e) Thermographic photograph 2 of the exterior of the ashlar office.

The photographs taken with the thermographic camera were taken in the spaces adjacent to the offices, either in the corridors or in the adjoining offices. Figure 3 shows the range of temperatures recorded in the walls and openings of the office of the ashlar building, mostly between 15 and 17°C surface temperature (Figure 3). On the other hand, while in the drywall office, the surface temperatures recorded ranged from 17 to 19°C, as shown in Figure 4.

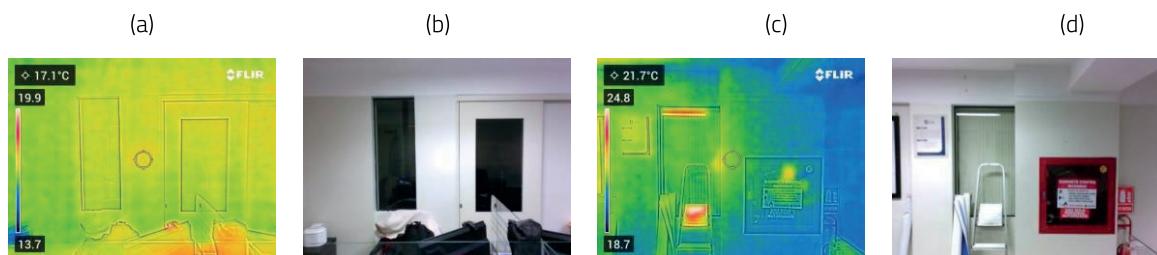
Figure 4. (a) (b) Thermographic photograph 1 of the exterior of room N202;
(c) (d) Thermographic photograph 2 of the exterior of room N202.
